Historic Conditions Report: Above-Ground Archaeological Investigations  
of the Old Treasury Building, Maryland State House Grounds

Conducted for State of Maryland  
Department of General Services  
Alvin C. Collins, Secretary  
DGS Project Number BA-491-070-203

Report Produced by John Greenwalt Lee Company  
Lead Investigator: Charles A. Phillips, AIA, AIC

November 24, 2008

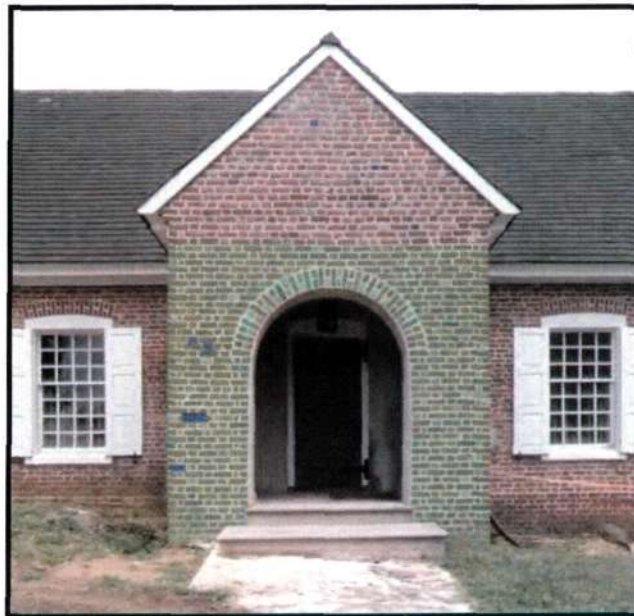
#### Front Portico

The front portico is not toothed or built into the rest of the building's brickwork and thus was not part of the original construction. However it is clearly constructed with mid-eighteenth century mortar, suggesting it was an early addition. Originally the portico had a hipped roof along with the rest of the building.

Green indicates earliest brickwork with area above having been added to create a gable.  
Blue indicates replacement bricks.

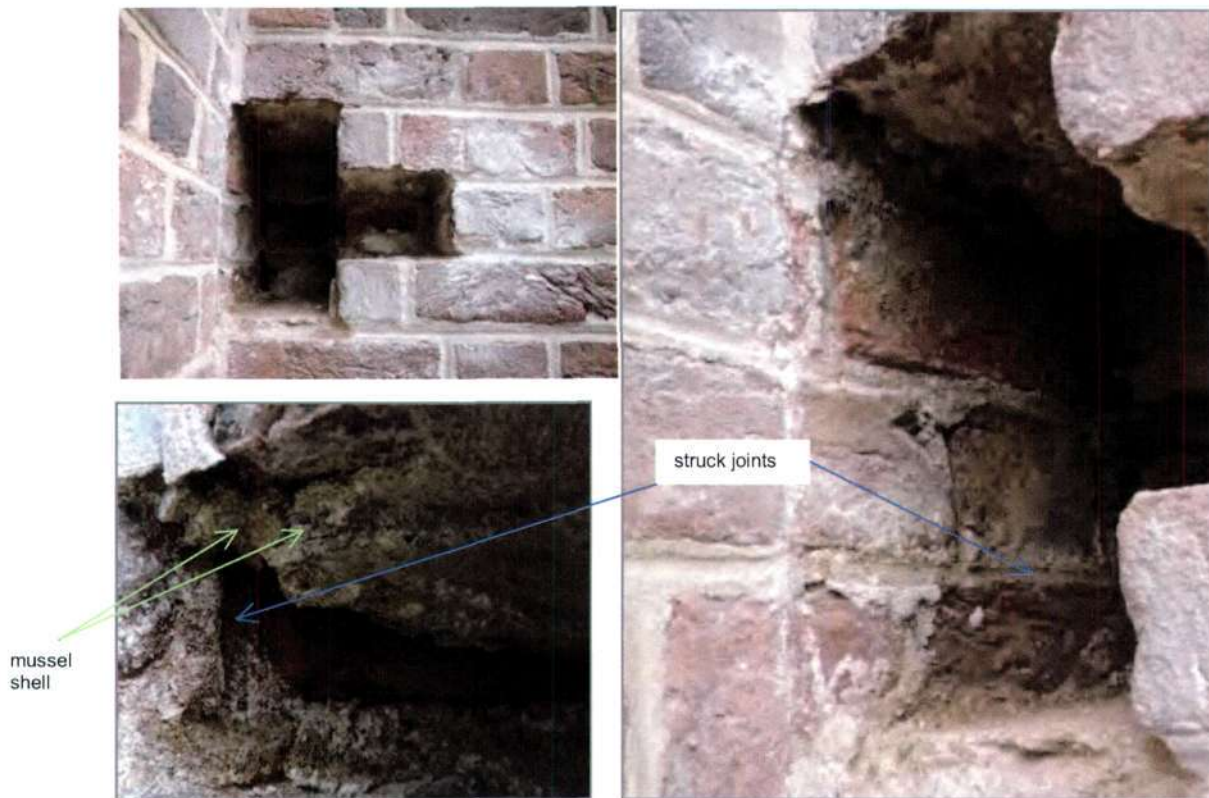
Similar to other early eighteenth-century mortars in Annapolis, this mortar is full of beach sand peppered with fragments of slate-gray mussel shell and bright white blebs of frozen lime. The blade width of the tool used to create the center-struck ruled line in the joint is wider than normal at 3/16". An eighteenth-century ruled joint is created with the use of a straight edge, unlike the modern grapevine joints seen around the cutout where the tool rides along the edges of the brick, increasing the apparent irregularity of the brickwork. In contrast, ruled joints created by rolling a Moxon-type jointer across a long straightedge produce a sense of uniformity in spite of irregular handmade bricks.

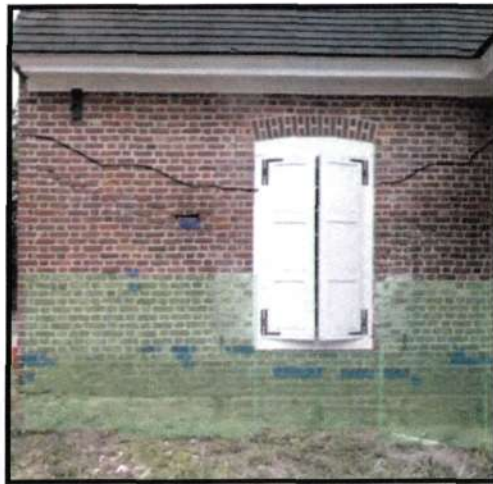
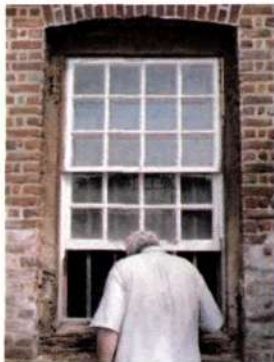
The rise in grade has caused moisture to rise to a very high point on this wall (black line delineating “tide line” denoting the congregation of salts. Some rebuilding took place underneath the window.

This is an original window and retains much of the original jamb, bars, and early shutters. The shutters on the interior were originally on the exterior.

Original window frames and bars with later double-hung (dual plane) sash replacing earlier casement (single sash swinging in)

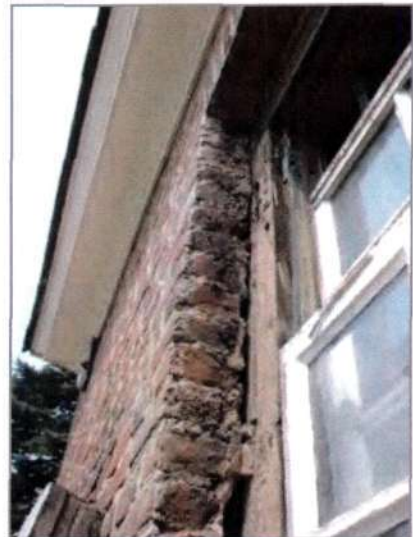
Brick arch supported by bricks cut to fit above wooden window

Original jambs are were built into original masonry with a crisp masonry return of 4" before wood  
Several generations of pintels have been mounted to the jamb and several paint schemes indicate different sash stops.

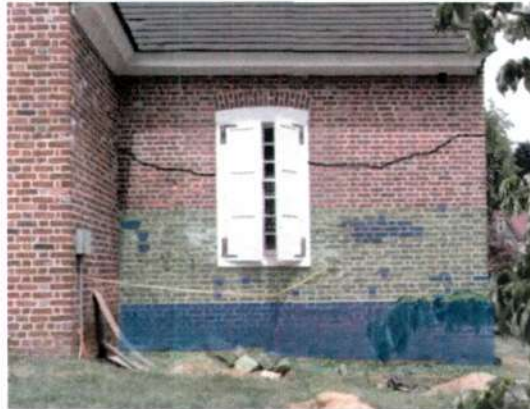
**Front Wall, Right of Portico, Elevation K:**

The base of this wall has been rebuilt in the twentieth century to the water table. The first phase of construction is still intact above to the middle of the window. The window appears to have an original frame hiding within nineteenth and twentieth century additions and alterations. The bars are original and the interior shutters are early though apparently made for the exterior.

Digging through fill dirt to find sterile soil, the stone apron has been removed and a clear demarcation within the stone foundations is visible where smooth-faced above-grade stones transition to more coarse below-grade stones .

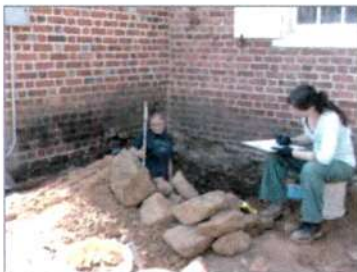
The stone apron was most complete in this front corner against the side of the porch.  
Pattern viewed from above

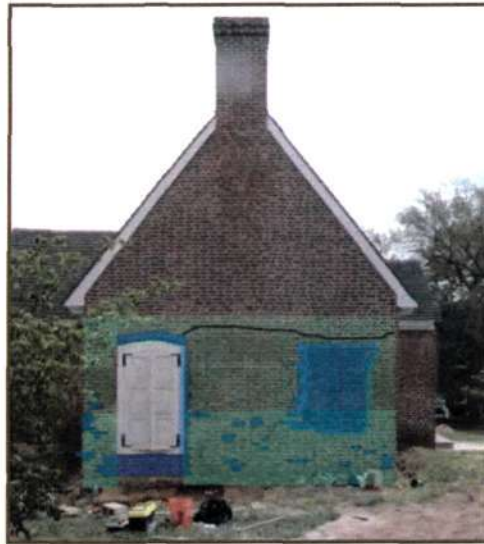
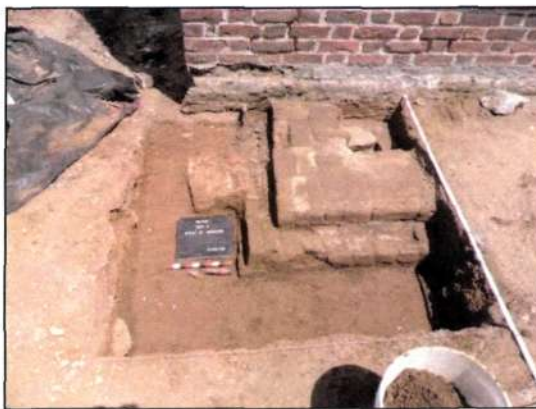
### Gable End Wall Facing State House, Elevation D:

The 1949 Hopkins/Fowler report cites a photograph of the West elevation with the presence of a door in the space currently occupied by a window. (*Accession: MSA SC 293 p.8*). Evidence of alteration to the arch and masonry on the right-hand side indicate the opening was widened to accommodate this large window. In addition, archaeologists recently discovered a stone stoop overlaid by an eighteenth century brick stoop below what is now a window. The grade around the building rose considerably with construction of an artificially elevated State House oval built to enhance the apparent influence of government and its hierarchy over the Church. This 1770s soil importation began a cycle that eventually led to the grade extending well up onto the brick walls, causing water damage from at least the beginning of the twentieth century. Masonry changes included closing in the right-hand window on the left side of the structure and changes to right of the current window. The evaporation/salt tide line on this face of the structure is just above the window arch (*meandering black line*).

Brick door stoop being uncovered by archaeologists  
Note the iron crimp for holding a timber in place and part of stone apron.

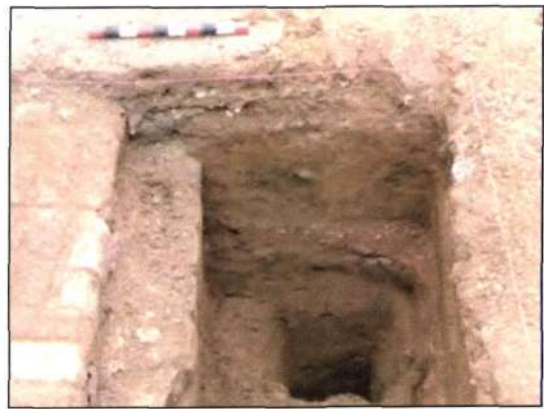
At right side of stoop, a post hole indicates doorway was covered.

The early brick stoop was a pyramid of steps with a wooden timber outlining each level and filled with bricks. There are nice hand-wrought straps set in the wall that attached to the timbers to hold them in place. The top step is missing. The floor height inside is one step above that.

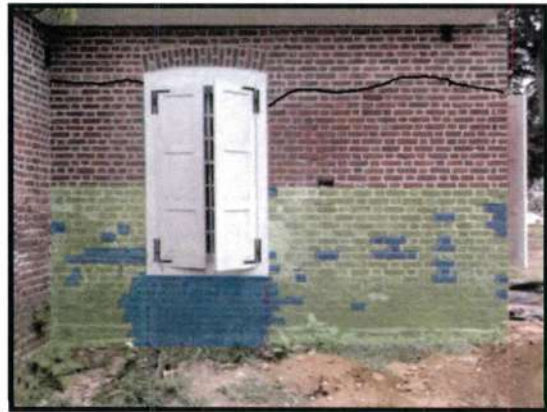
This portion of the wall had a 19<sup>th</sup> century shed added onto the structure, which prompted the modification of the window into a door. This window has been restored to the second quarter of the nineteenth century with eighteenth century-type shutters. The evaporation/salt tide line meanders across the upper half of the window frame.

When the interior portland cement plaster and tar were removed from the building in early winter, this and the D elevation here on the NW corner took three months to dry to a point the bricks did not remain blood red and cool/damp to the touch. (See masonry treatment report.)

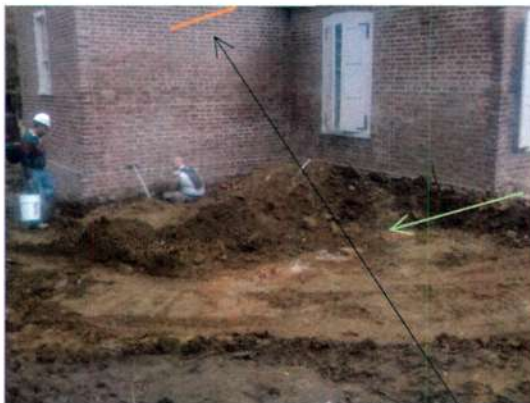
During recent re-grading of the site to lower the grade, bricks were uncovered in a line coming out perpendicular from elevation D to a point almost perpendicular with elevation G (gable end of wing), suggesting the shed at one time enclosed this area in an almost square box.

Later bricks uncovered  
in line with Elevation D  
suggest a large shed

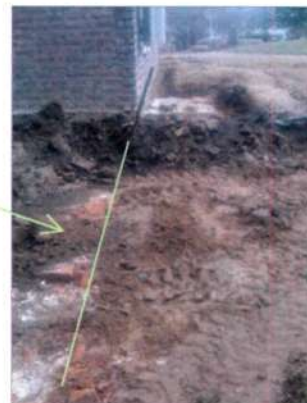
Additionally, a congregation of early nails (orange) in elevation F angled down from beneath the eaves on this elevation, suggesting the pitch of a shed roof.

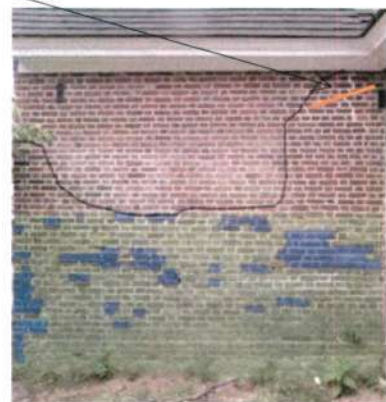
This wall clearly shows the two phases of construction. A large number of bricks have been replaced on this wall before 2007, but no clear pattern of alteration is apparent. Could these be related to attachment points for shelving or other uses inside the shed?

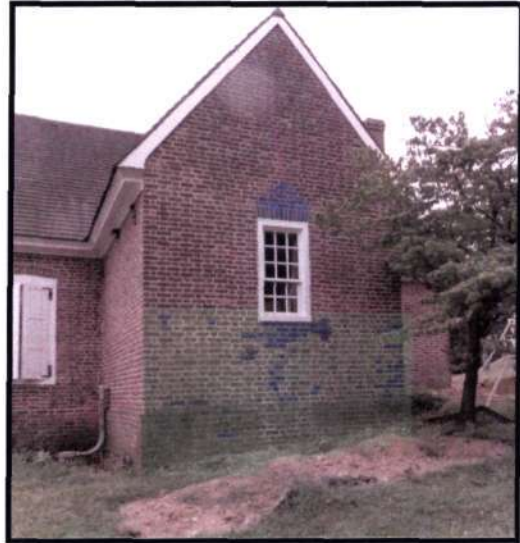
**Gable End of Wing, Elevation G:**

The arch above the window has been reconstructed, and has a crack leading up from it towards the roof. The cornice has been removed with the addition of the vaulted ceiling. The discoloration to the bottom of the building indicates the later grade line.

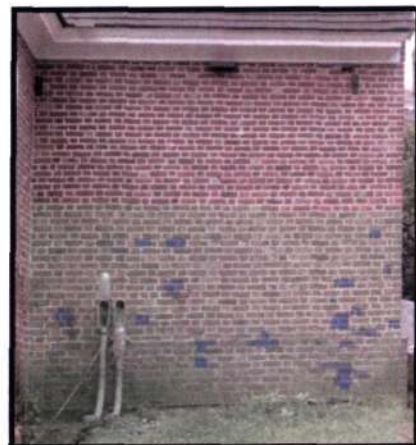
**Northeast Return Wall of Wing, Elevation H:**

This wall shows the two phases of construction clearly.

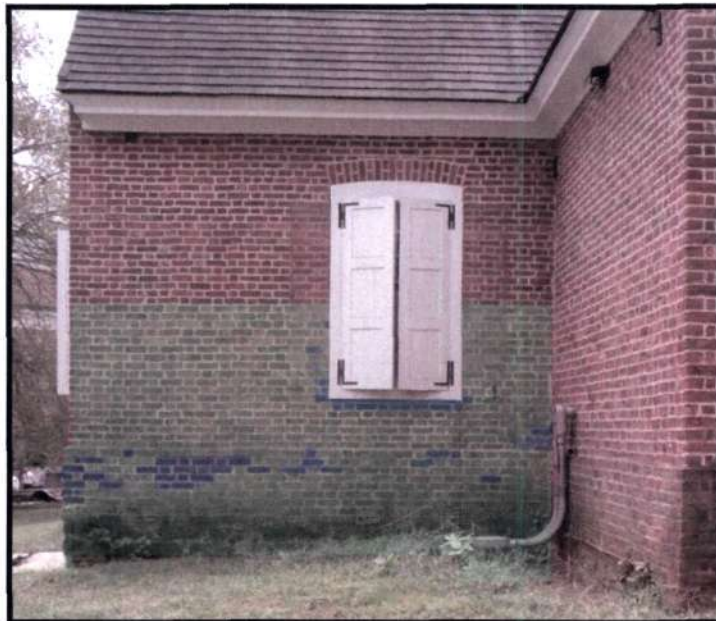
**Back Wall of Large Room, Elevation I:**

Repairs have been made to the bottom of the window. Ghost marks of the shutters show clearly around the window. This wall shows the two phases of construction clearly. Note the absence of a tide line on this elevation, since the stone foundations remained above grade.

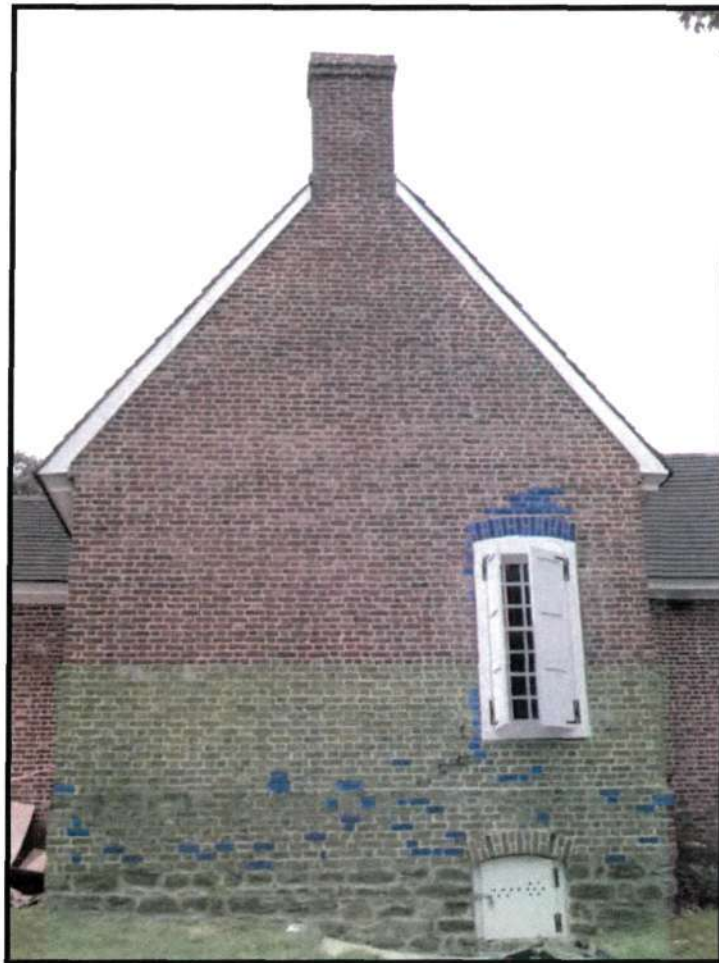
**Street-facing Gabled End Wall of Large Room, Elevation J:**

The cornice has been removed, and the ceiling vaulted. The window was cut in later, thus the arch and jambs are rebuilds. The door to the vault below has been shortened to half its original height.

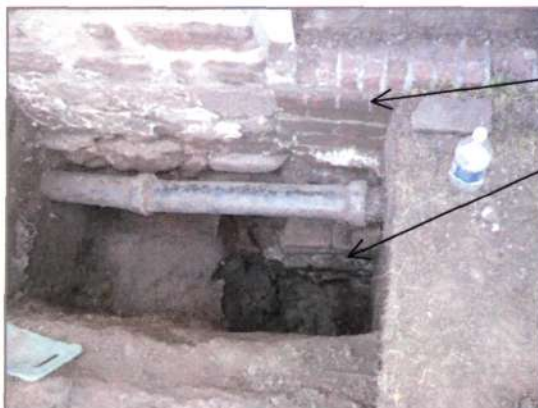
Vault entrance reduced due to grade rise.

Is brick build-out beyond face of wall (below pipe, left) related to an earlier attempt to reduce break-in possibility via digging under wall? [Vault door at earlier height extended to near base of foundation.]

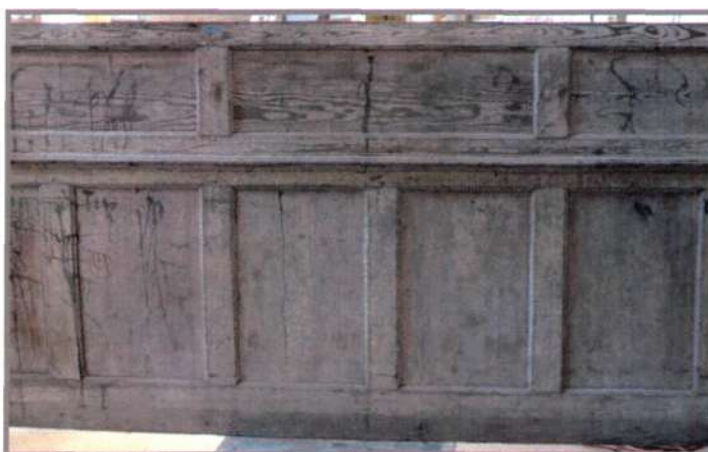
The pattern of nailing blocks implies a high wainscot paneling for this main room. The same construction phases visible on the exterior are also visible on the interior brickwork.

Chair rail

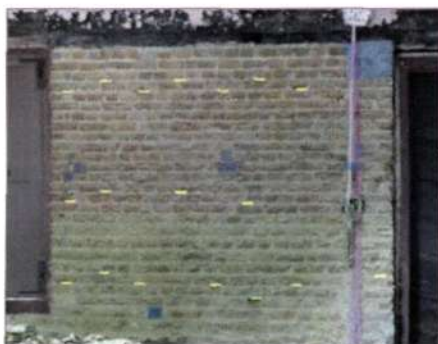
The front door is likely to be original. Note angled battens on the interior face in contrast to vertical boards on exterior, creating a strong security door. Unfortunately the frame was replaced in 1949.

Some rebuilding has occurred at the top of the door for a modern lintel (blue).

There is a distinct line between construction seasons (seen here highlighted with green along lower half).

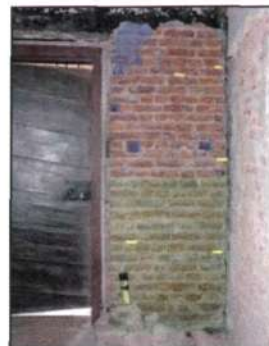
Wood blocks for attaching high wainscot (*above*) have since been replaced with bricks (*mid-wall line of blue blocks*). Lines of smaller wood blocks (*yellow*) set into joints were used to attach molding.

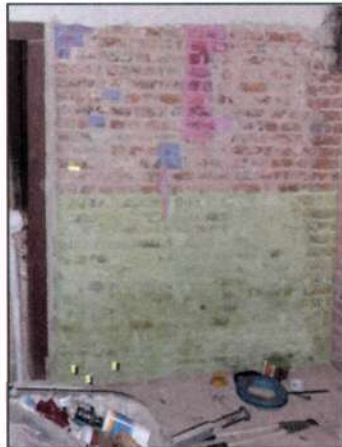
### Facing State House.

This wall has been altered for electrical wiring (pink). More brick infill of nailer block locations.

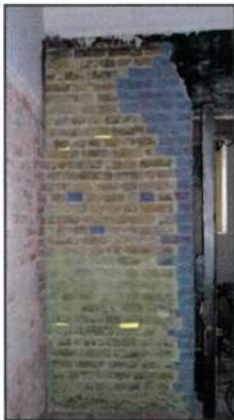
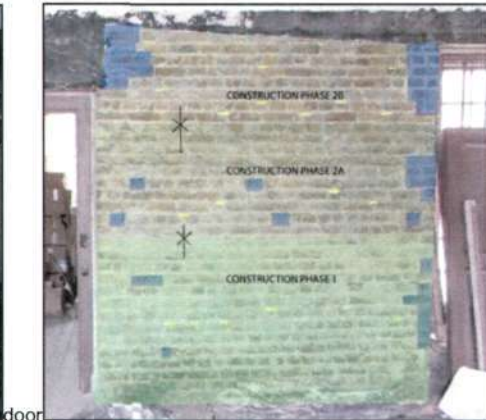
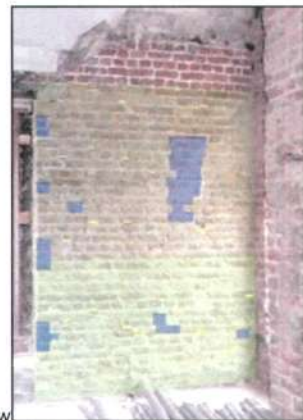
## Looking toward Back Wing:

This wall curiously shows three distinct early phases of construction where the others just show two. Rebuilding has occurred in patches through the length of the wall and along the left side of the door.

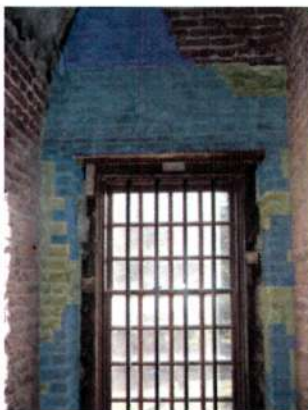
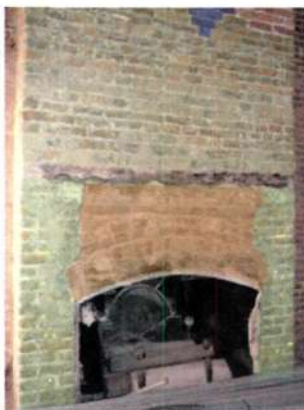
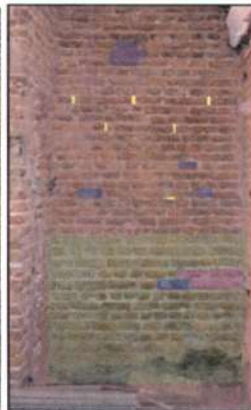
## Chimney Wall:

The window was cut in later.

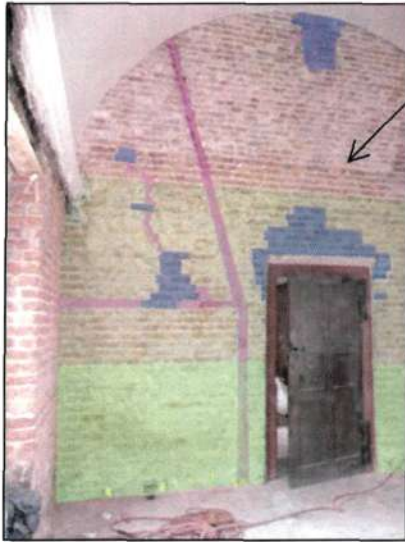
### **Wall Adjoining Large Room**

The wall above the flat ceiling line is constructed with materials that match the vaulting in the large room.

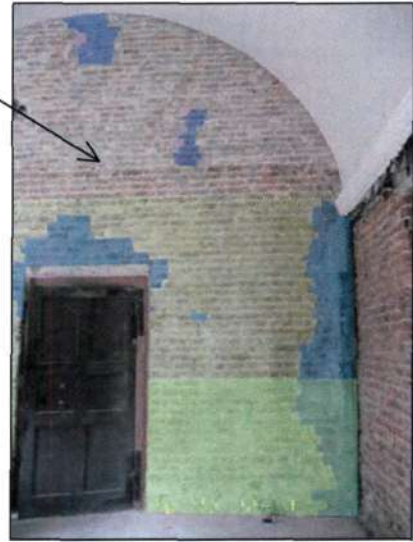
Although HABS devoted two pages of drawings to the lock on this door, the lock is a stock nineteenth century model. The door is eighteenth century.

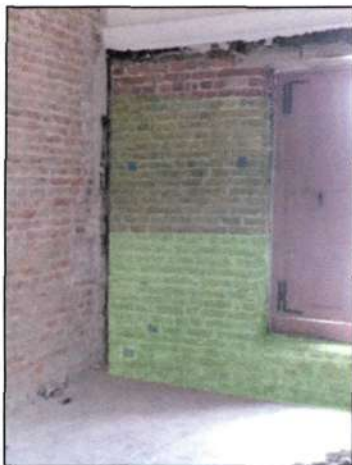
### **Front Wall**

This interior shutter may once have been on the exterior, having had the bottom rail cut down, possibly to fit inside.

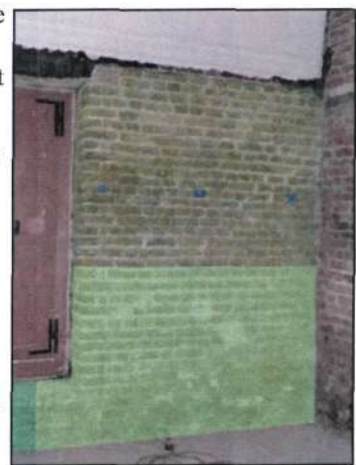
The line of brick infill (blue) again suggests high wainscot, although it would be less ornate in this small room.

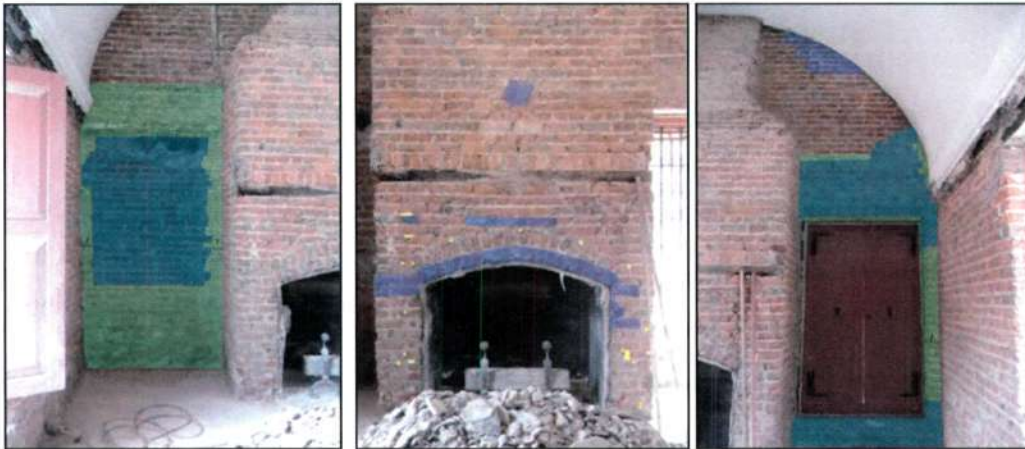
**Small Room continued:  
Chimney Wall**

A window to the left of the chimney has been infilled and the arch of the chimney has been reworked.

The window on the right hand of this wall used to be a doorway. The masonry next to the chimney shows evidence of the opening being enlarged for this purpose, causing an asymmetrical opening.

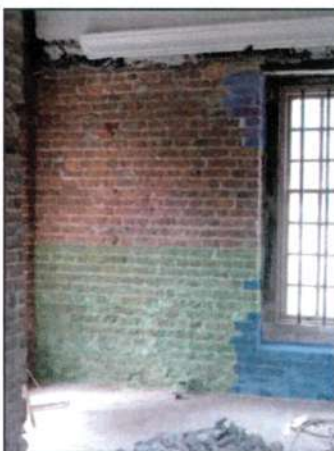
**Back Wall, Northwest corner of building**

The opening on the back wall of the small room has cycled from being a window paralleling the window on the front wall to a door out into an early nineteenth century shed room, and finally back to a window. The current frame is twentieth century with recycled nineteenth century material used for blocking.

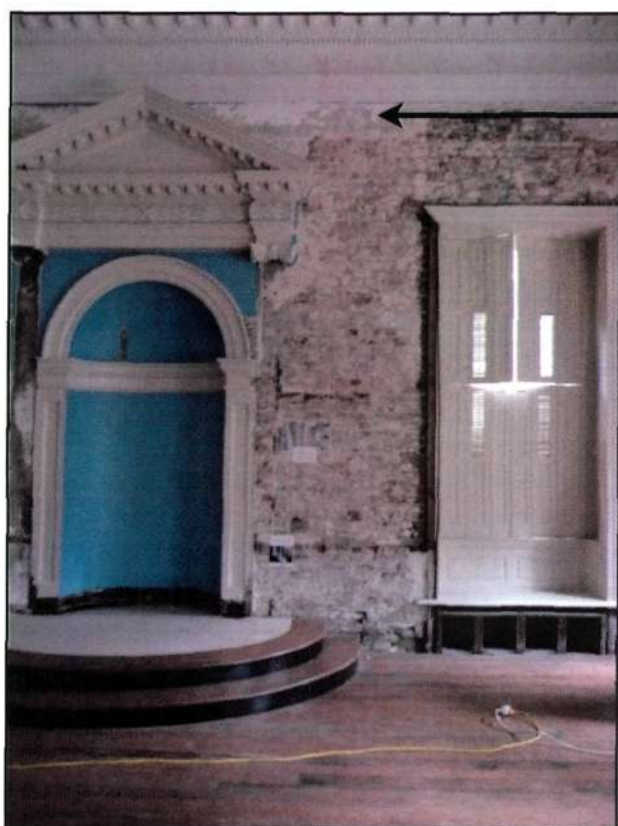
With 1905 blue wall plaster removed, note the 1878 wall plaster with intact finishes extends below and behind the 1905. The 1878 plaster is intact on the walls behind the current cornice and down about 3-1/2" onto the wall below.

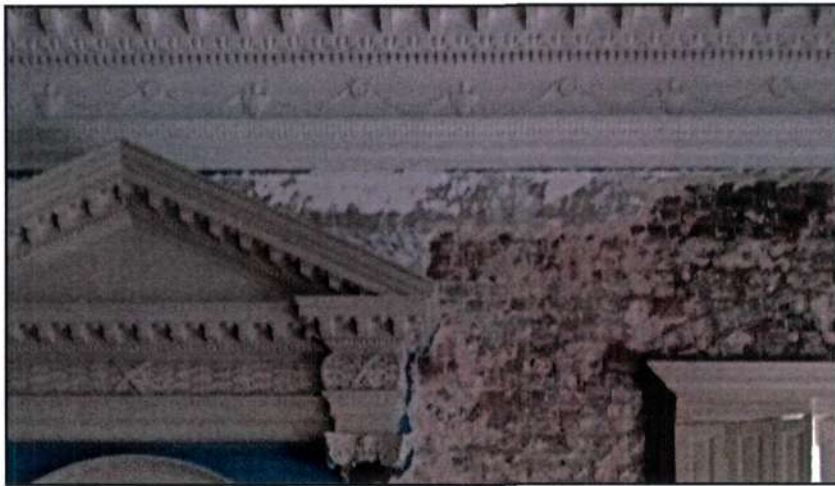
1905 rendition: Nothing is centered over the niche, but a rosette is nearest. Urns are sharply conical, sitting on a narrow base. Large rosettes hover higher than urn tops, leading to an asymmetrical drape of the swags. Swags do not touch bottom of band.

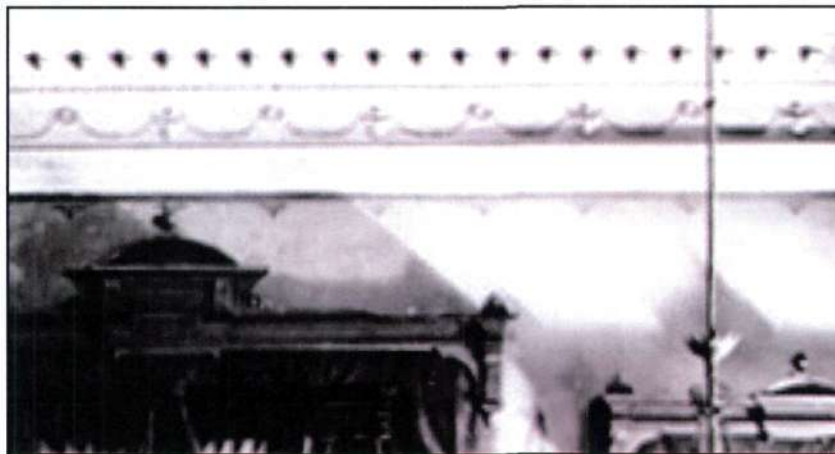
1878 cornice: An urn is centered over the niche, swags are considerably more flattened, nearly resting on the bottom of the band and rising higher on urn with a wider spacing between elements.

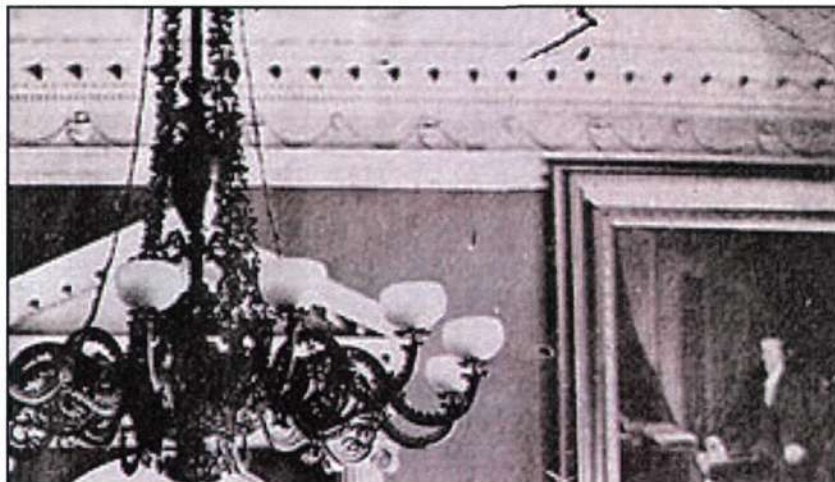
1868 view: Urns are much stouter and very rounded swags touch the bottom of band before rising to mid-point on urns.
